STATE OF ILLINOIS DEPARTMENT OF TRANSPORTATION

NORTH ABUTMENT DETAILS STRUCTURE NO. 049-0152

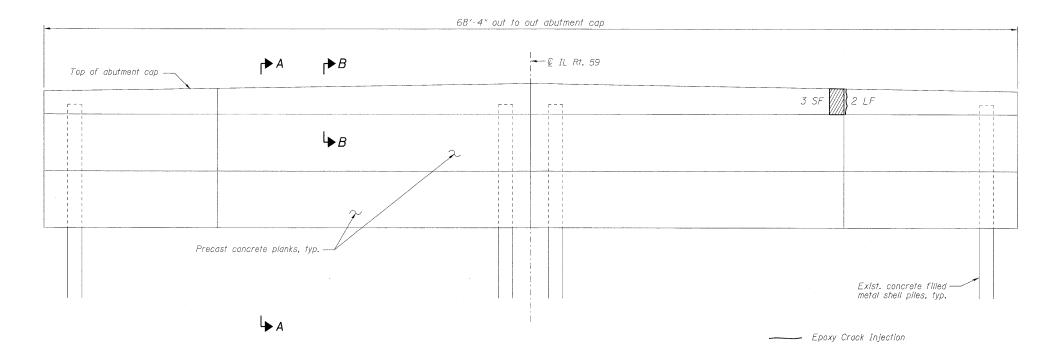
<u>ELEVATION - REMOVAL AND REPAIR</u> (Looking North)

Approach slab

6" 2'-0"

Concrete Wearing Surface

11" P.P.C. Deck Beams

Existing vertical reinforcement to be reused
